Home Inspection Report

Fleet
Inspections

Friday September 2, 2016

160902A

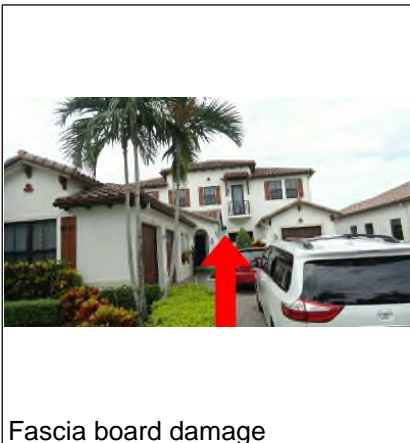
Comments Observed section(s) of fascia rotted/damaged, Recommend reevaluation and repair by a licensed contractor .

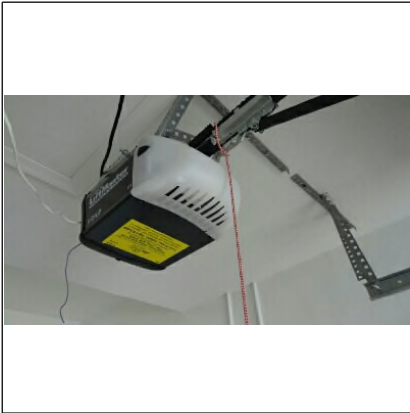
2 of the garage doors do not have automatic openers.

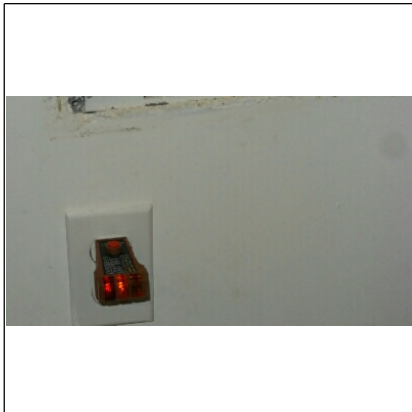
Comments One electrical receptacle recommend was wired incorrectly. Reverse polarity is a potential safety hazard. Recommend repair by a qualified electrical contractor

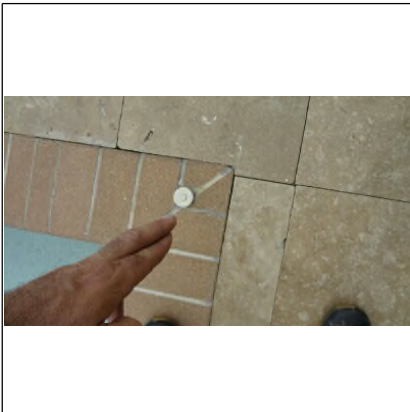
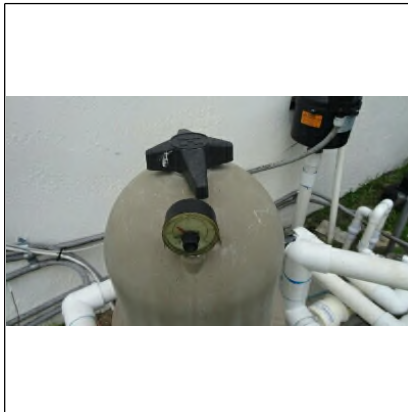
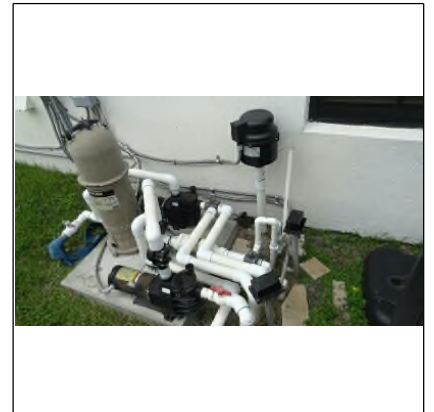
Comments Spa blower was not working when inspected. Recommend repair as needed.

Recommendations Recommend pool technician repair/evaluate/service
